The Public Gaol Architectural Report Block 27 Building 2

ARCHITECTURAL REPORT PUBLIC GAOL Block 27, Building #2

ARCHITECTURAL REPORT PUBLIC GAOL (Reconstructed) Block 27, Colonial Lots 279 & 280

This report was prepared by Singleton P. Moorehead
for the Department of Architecture
March 4, 1936.

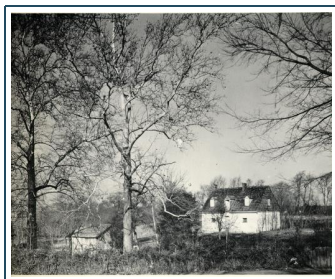
THE PUBLIC GAOL AS IT EXISTED JUST PRIOR TO ITS RESTORATION.

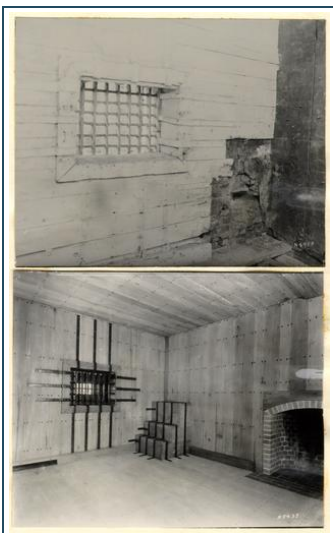
PRISON CELL BEFORE & AFTER RESTORATION

This wall was covered with pine planks as the outside walls in Cell B - set vertically. The usual base ran across as in these cells. After removing this planking the brickwork was exposed and proved to be all later, of the period of the city alterations. From the ledge upward this was true, from the ledge downward the work was original being laid in English bond with more or less unfinished surface. At points here and there the ledge had been patched and repaired. For remarks on brickwork below level of ledge see Foundation Plan notes for east portion. Wood stringers are let in the brick as in the original work - to which the furring for the late planking was nailed. At the east end of this wall was a diagonal passage through the brickwork leading from a former toilet seat in the north east corner of the room to the pit outside. This passage was partially ruinous and the wooden pipe was gone. The marks of the former seat still remained on the planking. See photo N 4960 showing this corner with late planking removed where pipe went through brickwork.

The upper photograph is a view of the north wall of Cell D of the Public Gaol before the restoration of the building. (For location of this room, see measured plan, 3-M). The wrought iron window grille and the iron straps on the interior are original colonial features which were reused when the building was remodeled by the city. The pine planking covering the brickwork is late. The outline of a former toilet seat similar to the reconstructed one shown in the lower illustration may be seen. The aperture in the brickwork of this area is the inside opening of a diagonal passage which lead to a pit on the outside. Original details such as these and others found in the old building formed the basis for the reconstruction of like features in the restored Gaol.

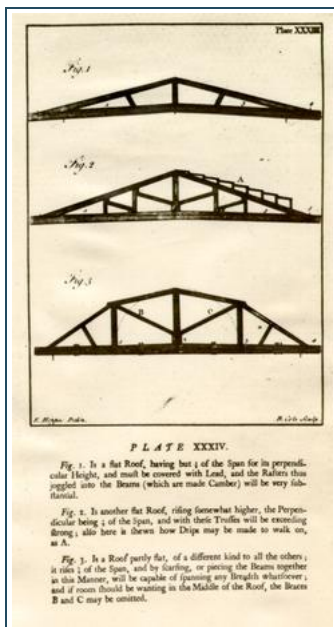
ROOF OVER DEBTORS CELLS OF GAOL
PLATE XXXIV

IN 1711 TWO CELLS FOR DEBTORS WERE BUILT AGAINST THE WEST WALL OF THE EXERCISE YARD OF THE EXISTING GAOL. IN HIS " *HISTORY OF VIRGINIA* " (LONDON, 1722) ROBERT BEVERLEY WROTE AS FOLLOWS:
