# *Barraud (Dr.) House Architectural Report, Block 10 Building 1 Lot 19*

## *ARCHITECTURAL REPORT BARRAUD HOUSE*

### **Block 10, Colonial Lot 19, House No. 1**

This report was prepared by A. Lawrence Kocher and Howard Dearstyne for the Department of Architecture  
(Architectural Records)

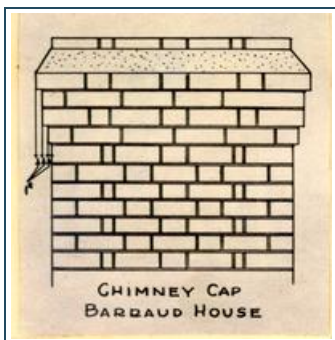
SKETCH — CHIMNEY CAP BARRAUD HOUSE

The chimneys are end chimneys built within the area of the house. The stacks at the top are approximately square in plan. The precedent for the chimney cap (see accompanying sketch) is the cap of a chimney at Hungar's Glebe, Northampton Co., Va. <sup>4a</sup>

It was not possible to use the old chimneys as a model since there was evidence of this having been changed.

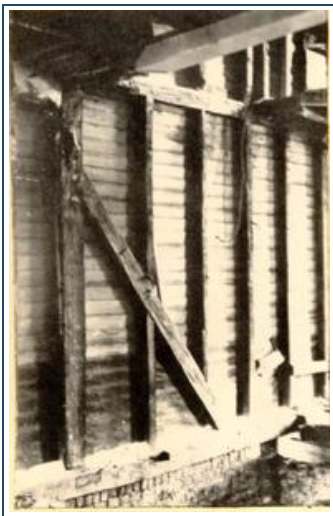
Weatherboarding was applied directly to this rough-hewn frame (see photograph at left.) This photograph is believed to reveal a braced cornerpost which was either a terminal to a partition or could even have been the north-east cornerpost of an early first form of the house. Such an assumption is in agreement with the theory that certain spliced rafters found in the attic were remnants of a roof of lesser depth than the roof as found in 1941 and as reconstructed.

Photograph showing "braced framing" at east end of house. The heavy vertical post is considered as a possible corner of house, before widening at some early date. Bracing occurs, normally, only at corners of buildings.

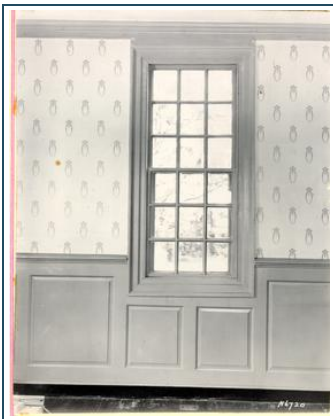
Above: View looking north-east, showing original paneling, and, at right, original door to hallway. Door opening at left, which cut through a panel section, was obviously recent and was therefore closed.

At left: View of west wall showing window with original sash.
