# *Roscow Cole House Architectural Report, Block 19 Building 13 Lot 162*

*Originally entitled: "Architectural Report Norton-Cole House ('Peachy-Rogers House') Block 19 Building 13"*

George S. Campbell, Rev. A. Lawrence Kocher and Howard Dearstyne

1933, rev. 1951

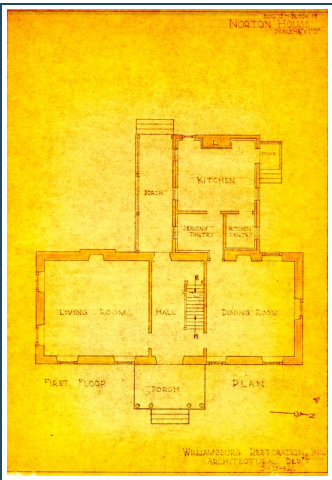
FIRST FLOOR PLAN

First floor plan consists of main portion which faces east. This is divided into two rooms by a hall running east and west and which contains the stairs. The room on right hand side is the dining room, while the room on the south or left hand side is the living room. A new wing was built at the rear of the dining room with a porch, access to which is through rear door of main building. This contains the kitchen, serving and kitchen pantries, and has service through a new door at side of fireplace to dining room. The original colonial arrangement was the reverse of the present, and so the service door was closed up on other room, now the living room.

A door which gave access to a modern frame kitchen on north side was changed back to a window in dining room at the north-west corner.

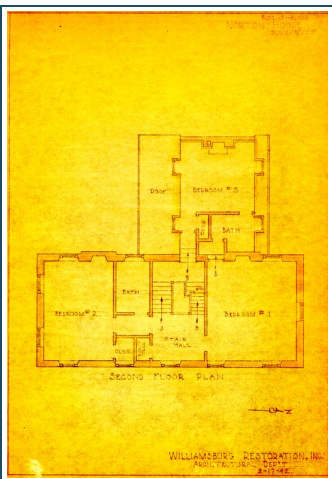
SECOND FLOOR PLAN

Second floor plan in main building is similar to first floor except that in (main building) south bedroom was partitioned off to provide a bathroom, and also to give a closet for this room and a linen closet for hall. North bedroom was given access to a new bathroom in wing by making a door similar in relation to door below from kitchen to a dining room.

Steps were made through from main stair landing to give access to bedroom in wing. Also a window which was in place at this point was removed. Bedroom of the wing has access to bathroom on wing side as has north bedroom. A modern door opening which led to modern bathroom in frame addition north side in north bedroom was filled up.

New windows were formed on west wall of south bedroom for utilitarian purposes.
