*Archibald Blair's Storehouse (NB) Architectural Report,  
Block 18-1 Building 6A Lot 46*

A. Lawrence Kocher and Howard Dearstyne

1949

*ARCHITECTURAL REPORT  
ARCHIBALD BLAIR'S STOREHOUSE  
Block 18, Colonial Lot #46*

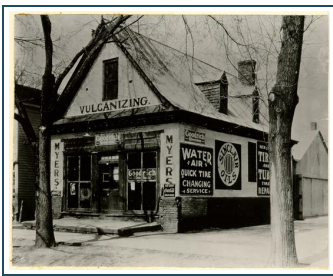
The condition of Blair's Storehouse before its restoration may be seen in a photograph (N3614) in the Colonial Williamsburg files of progress photographs. It was in use as an automobile service station and the wall above the watertable and the brickwork of the front gable end, had been given one or more coats of white paint upon which a number of advertising signs in various colors had been superimposed. In spite of its disfigurement by painting and advertising matter the shell of the building was, surprisingly enough, more or less intact. The pediment with its modillion cornice still existed and furnished the model for the restoration of this feature. The large window opening of the service station evidently represented the opening of the old shop front, since the jambs at either side were found to be constructed of old rubbed brickwork and were doubtless original. The old detailing had, however, long since disappeared and had been replaced by late 19th or early 20th century woodwork and glazing. A stone platform, supported on brickwork, extended across the front, but there were no additional steps as at present.
