# *Barraud (Dr.) House Architectural Report, Block 10 Building 1 Lot 19*

## *ARCHITECTURAL REPORT BARRAUD HOUSE*

### **Block 10, Colonial Lot 19, House No. 1**

This report was prepared by A. Lawrence Kocher and Howard Dearstyne for the Department of Architecture  
(Architectural Records)

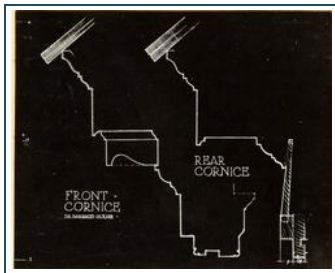
### **Main Cornice — South Elevation**

The south cornice was considered the main cornice since it alone is given dignity by use of modillion blocks to support the cornice overhang. The rear cornice is plain without evidence of the brackets having been removed when the rear porch was added.

The cornice overhang is not great. It measures 9 9/16" from the face of studs to the vertical fascia below the crown moulding. The brackets themselves are only 4 3/4" in horizontal length; their spacing is 9 1/2" center to center. The under side of the brackets has been cut away in a graceful reverse curve.

The main cornice is original, but required the repair or replacement of parts of moldings or brackets. Cornice and boards were gone and new ones were required; the rake boards of the gables and all shutters appear also to have been found to be modern, requiring replacement by new ones. Almost all window frames and their sills were old and presumably original. Window sash, perhaps the most vulnerable part of a house, were found to be modern everywhere on the south and north elevations, but five original sets of sash were found at the gable ends. There were a sufficient number of dormer parts that were accepted as old and original to permit the reconstruction of these from the house itself. #

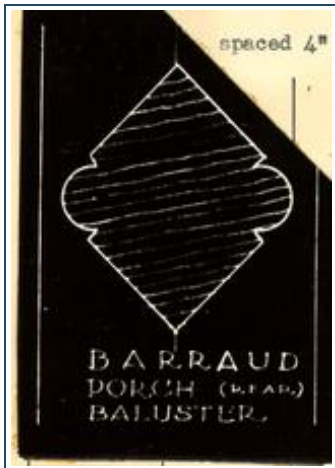
Barraud Porch (rear) Baluster

placed diagonally for greater strength as are the horizontal bars of the basement windows. The corners of the balusters facing outward and inward are provided with 3/8" bead. The handrail and bottom rail of the porch railing are similar in profile to the same rails of the front porch, but they are somewhat lighter in section.

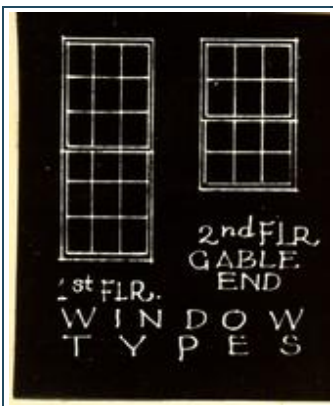
Window Types

The determination of the use of molded sills for a part of the house was based upon the existence of two such sills, found in place. Other sills were square-edged, and appeared to be recent additions. The house had evidently been added to at some time during its early history so the architects in charge of its restored design considered that the added part could very well have been altered from the rounded profile to the "square" sill. the design of the latter was based, of course, upon many similar ones within the restored area of Williamsburg.

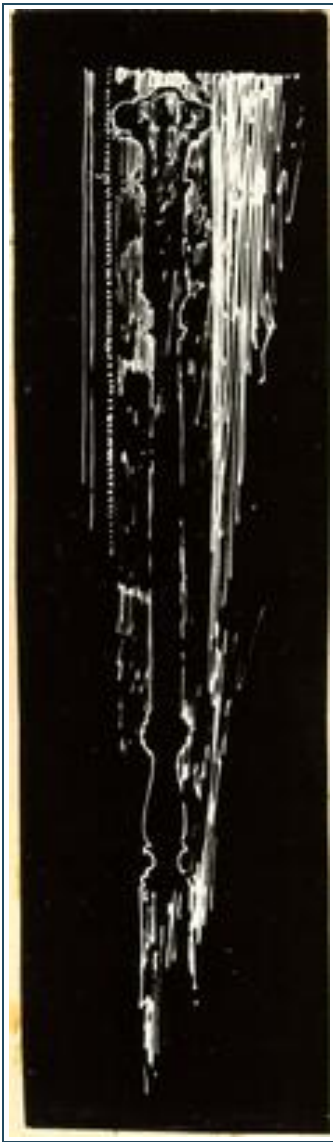
The stair found in place when the Barraud House was restored was a completely modern one and consequently the entire stairway was replaced. The new staircase was reconstructed at the north end of the hallway on the basis of evidence discovered when the existing stair was removed. The position of the newel at the foot of the stair was determined by a notch in the floor by means of which the old newel was secured. Notches for the spandrel studs further indicated the position of the initial flight of the stair. The size and position of the stair platform was determined by the discovery of the old platform flooring underneath the existing flooring when the latter was removed. The position of the handrail in the second floor hallway was clearly determined when the removal of the paint on a wood post against the west wall revealed the impression of the original handrail and the profile of the baluster.

In the reconstruction of the stairway the impression of the old handrail and baluster mentioned above as having been discovered on the second floor of the house was copied exactly so that the new rail and baluster are as close as possible an approximation of these features of the original stair. The newels used on the stair runs and landings are square in section (3½"x 3½") and the profile of the cap repeats that of the handrailing. The newel at the foot of the stair rests on the first tread. It is of interest to note that the balusters of a stair rail found at Liberty Hall (Hanover County) are similar in profile to those of the Dr. Barraud House, though the proportions of the elements of the balusters vary in the two cases. The newel cap follows closely the design of the newel cap of the old west stairway of the Coke-Garrett House.

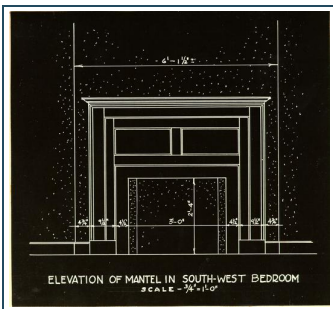
Elevation of Mantel in South-west Bedroom

Of the six mantels two, those of the dining room and south-west bedroom are old mantels found in the house, which were repaired and reused. The remainder are new mantels, whose design has been based on eighteenth century precedent.
