William Lightfoot House Architectural Report, Block 11 Building 14 Lot 13 & 14

THE LIGHTFOOT (NIGHTINGALE) HOUSE AND OUTBUILDINGS

BLOCK 11, COLONIAL LOTS 13 & 14, BUILDINGS 14, 14A, 14B, 14D, and 12B

The *Lightfoot House, Dairy and Smokehouse* were restored by the Williamsburg Holding Corporation under the direction of Perry, Shaw and Hepburn, architects.

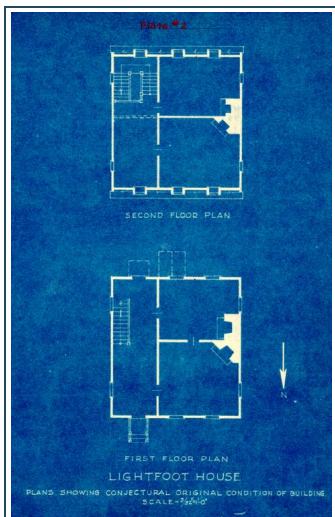
LIGHTFOOT HOUSE
PLANS SHOWING CONJECTURAL ORIGINAL CONDITION OF BUILDING.
SCALE-3/322'=1'-0"

The Lightfoot House is a one-and-one-half story, gambrel-roofed building of frame construction faced with weatherboards. Its plan (Plates 1,1a,2), roughly square with a hallway on one side, is a departure from the commonly found Virginia house plan with a central hall flanked by a single room on either side. The first floor plan has a side hallway running the full depth of the building, giving access to two inter-communicating rooms. This floor arrangement suggests the possibility, for which, however, no confirmation has been found, that this type floor plan may have been intended originally for later enlargement into the two-room deep central hall type. These two rooms, which were used in colonial times, presumably, as living room and dining room, have corner fireplaces united into a single chimney, which is contained within the exterior wall of the house. The second floor, approached by a stairway at the rear of the stairhall and occupying its full width, has a similar plan, with two bedrooms located in positions corresponding to those of the rooms below. These rooms are likewise provided with corner fireplaces which are situated over those of the living room and dining room (the present kitchen).

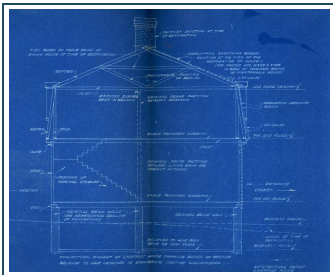
In discussing the framing of the Lightfoot House roof we are handicapped by a lack of precise information. At the time of the restoration of the house no descriptive notes were made of the framing of the roof. Two progress photographs (N583, N584) were taken of the upper slope of the roof stripped of the tin roofing with which it had been covered. These reveal the upper ends of a series of roof rafters spaced about two feet on centers, meeting in mortise-and-tenon joints secured by wood pins. There is no ridge pole. The rafters are covered with overlapping sheathing of varying widths, some of which is beaded, suggesting that the material had one time served as weatherboarding. In the absence of further information on the framing of the house a diagram (Plate #6) is herewith presented which gives an hypothetical framing system based upon a study of

the roof framing discovered in the Moore and Ewing Houses when these buildings were stripped preparatory to restoring them. The braces shown in the "truss" of the upper slope were not found in the Moore and Ewing Houses but were added in the restoration of these houses. It seems likely that such braces would have been required from the outset in the Lightfoot House due to the span (ca. 29 ft. 6 in.) and the relatively low slope (ca. 23°) of the "trusses." A feature of interest shown in the diagram is the exposed summer beam spanning the upper hallway to support the ceiling joists of the second floor. This is an original eighteenth-century feature which existed in the house at the time of its restoration.

Despite the fact that the framing diagram is based upon actual examples of framing uncovered in houses of the eighteenth century, there is a reasonable doubt that this represents the framework which existed in these houses at the time they were built. In view of this two plates (Plates #7 and #8) are reproduced here from eighteenth-century handbooks (William Pain's *The Carpenter's Pocket Directory*, 1785 and the same author's *The Practical House Carpenter*, 1788), showing variations of a system of gambrel roof construction much in use for frame buildings in England during the period. Since English methods of construction and English handbooks were widely followed in the colony there is some likelihood that a form of the truss system represented in these diagrams may have been employed in the original construction of the Lightfoot House. In this event trusses such as those represented in Figure C, Plate #8 would probably have been placed over the end walls and the partition of the stair hall, with one possibly midway between stair hall partition and the west wall of the house. Between these trusses lighter rafters would probably have been placed to
